SPARC® Enterprise M4000/M5000 Servers Product Notes

For XCP version 1050

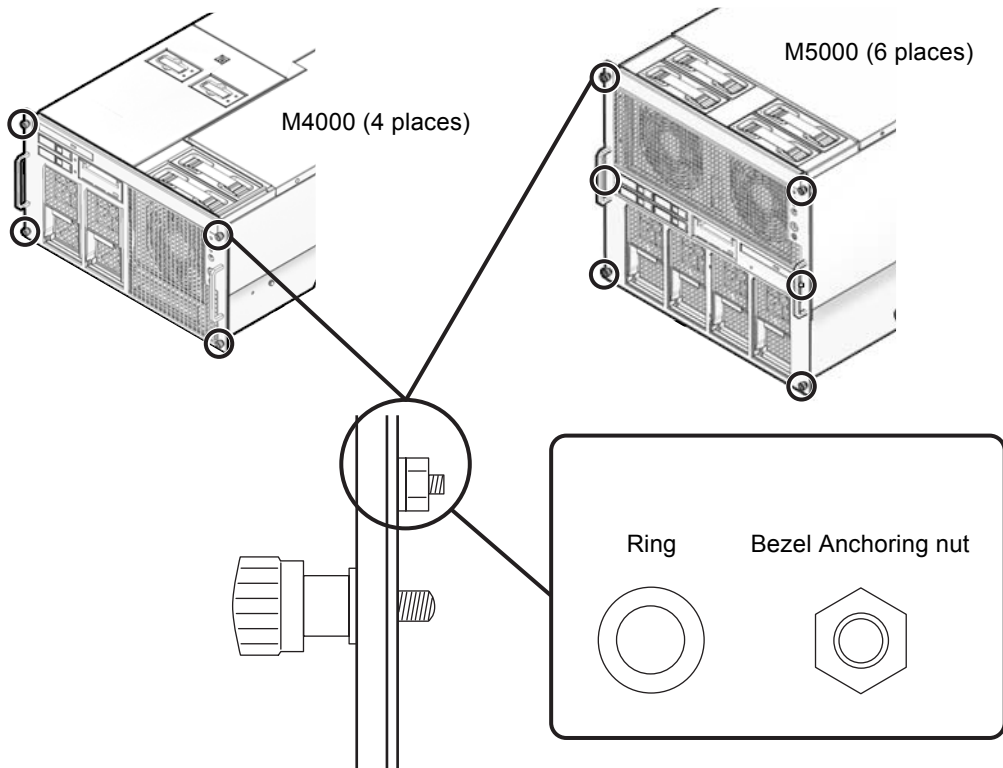
When you mount the SPARC Enterprise M4000 or M5000 server on the 19-inch rack, as you insert it all the way seated in the rack, the nut anchoring the bezel may interfere with the rack column and the server may fail to be seated correctly.

1. Remove the interfering bezel anchoring nut and ring.

In such a case, please replace the bezel anchoring nut and ring with the E-Ring.
